# Clean Air Notes

# TECHNICALLY SPEAKING

# Diagnosing & Repairing EGR Systems: Spotlight on Linear EGR Valves

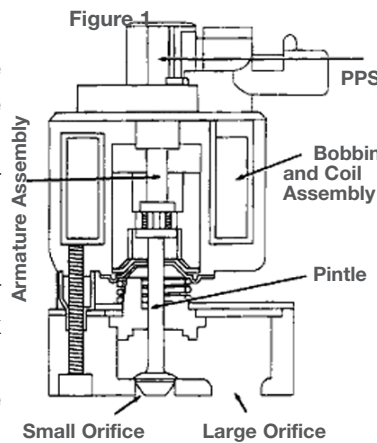
that has graphing capabilities. In Figure 2 you can see the pintle position graph quickly going vertical and then ramping smoothly after that point. This is caused by a dragging pintle and was causing a repeatable P1406 pintle position error code. Most of my experiences with these valves were regarding intermittent or pending codes. This prompted me to find a way to evaluate pintle drag outside of scan data. I developed and have used this test often. To try this for yourself you will need a low current probe, a two channel lab scope and a way to ground the EGR solenoid to lift the pintle (a power probe works great for this).
